S/22863
31 July 1991

LETTER DATED 31 JULY 1991 FROM THE SECRETARY-GENERAL
ADDRESSED TO THE PRESIDENT OF THE SECURITY COUNCIL

PRELIMINARY REPORT OF A UNITED NATIONS TEAM, APPOINTED BY THE SECRETARY-GENERAL IN ACCORDANCE WITH SECURITY COUNCIL RESOLUTION 598 (1987), PARAGRAPH 7, TO OBTAIN INITIAL INFORMATION AND DATA ON THE NATURE AND EXTENT OF THE DAMAGE SUSTAINED BY THE ISLAMIC REPUBLIC OF IRAN AS A RESULT OF THE CONFLICT BETWEEN THE ISLAMIC REPUBLIC OF IRAN AND IRAQ, AND ON THE STATUS OF THE FORMER'S RECONSTRUCTION EFFORTS

31 MAY 1991-21 JUNE 1991

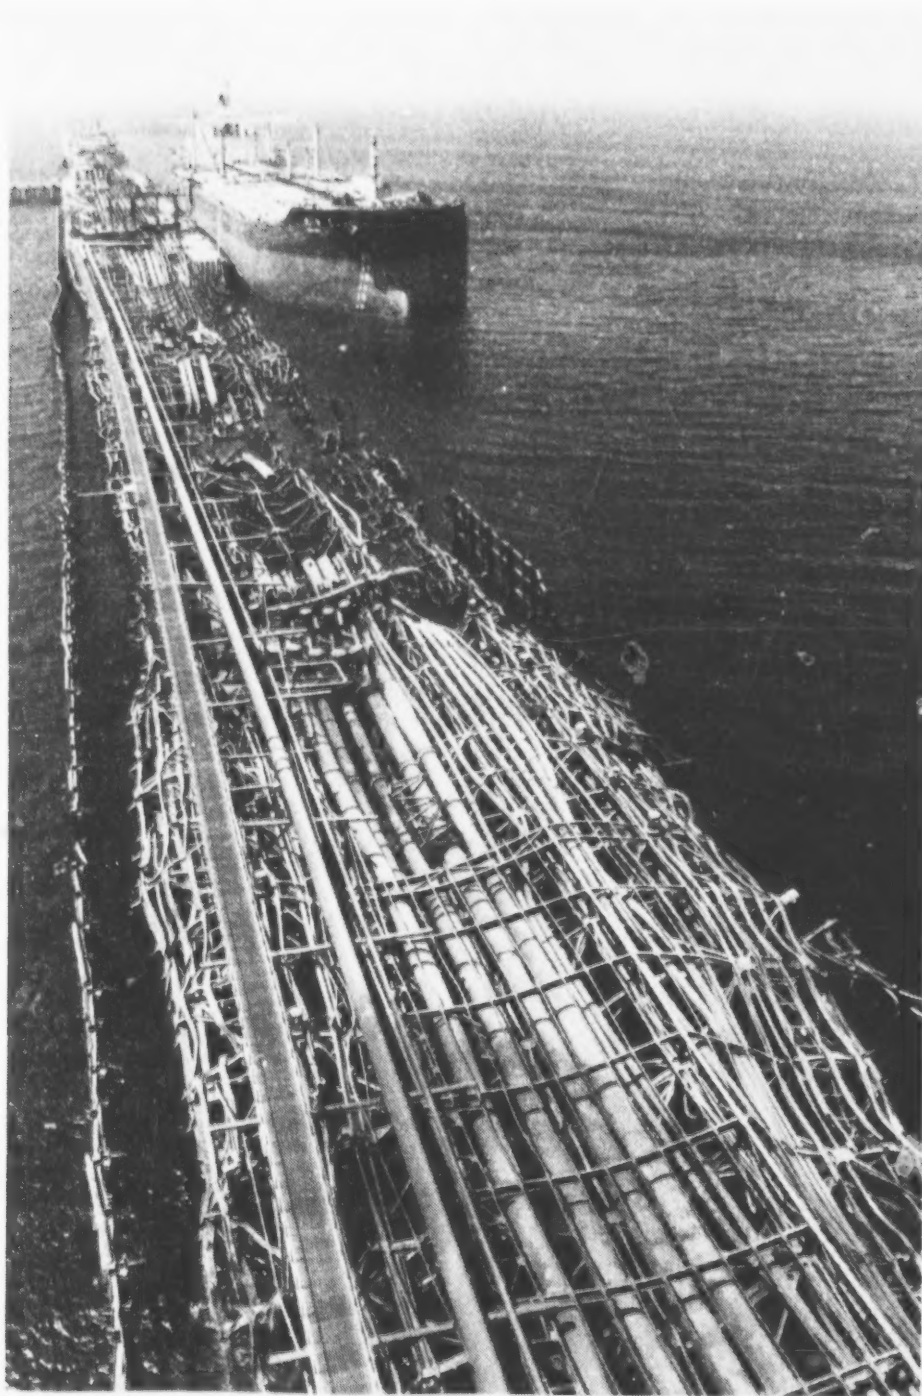
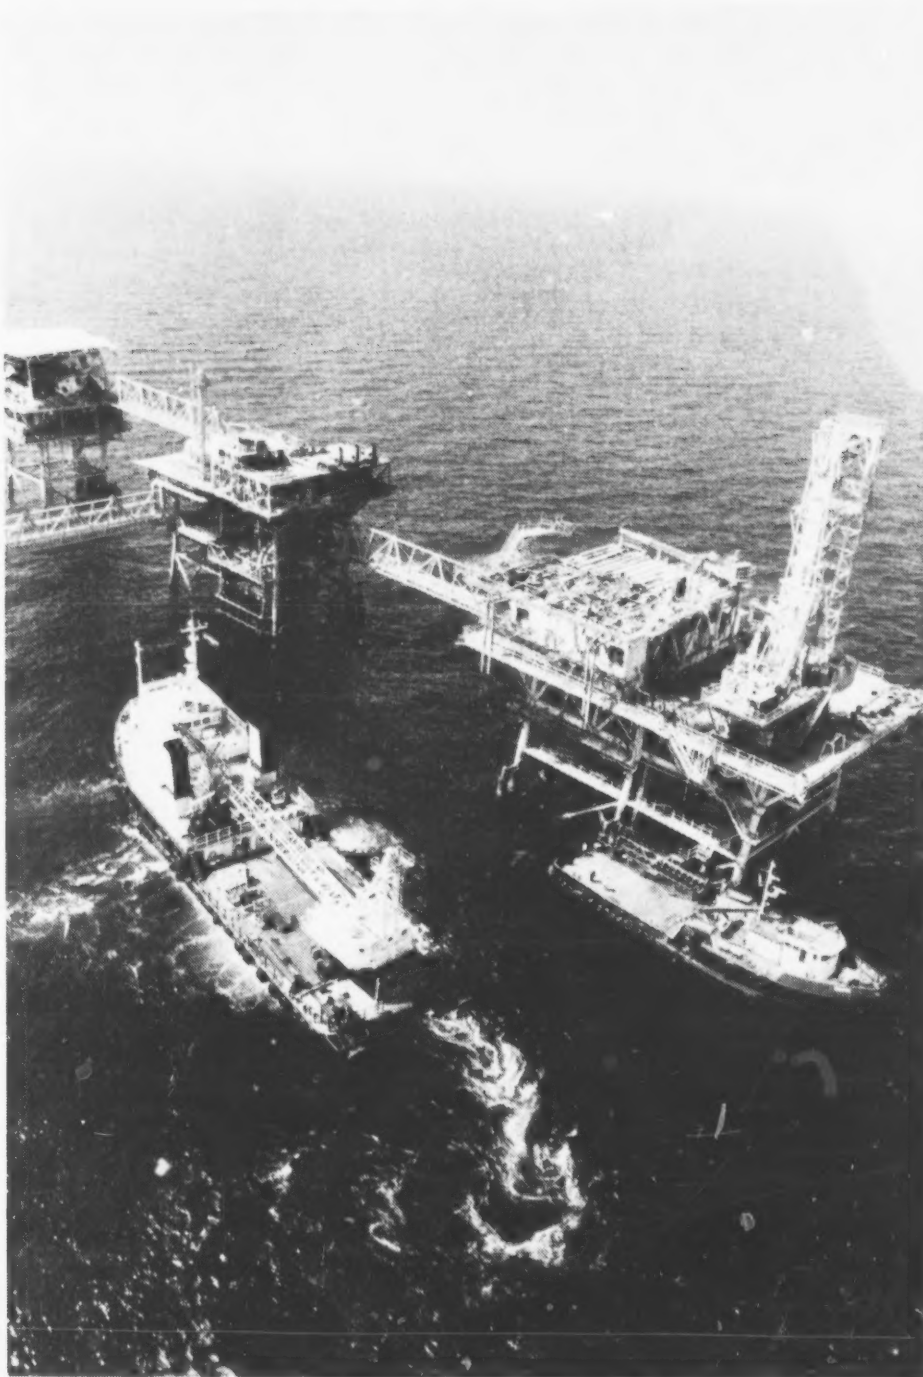
264. Lavan Island itself was attacked towards the end of the war with much damage to tankage and the jetty, which had been able to accommodate medium-sized tankers. The island has two separation plants, one for each of the Salman and Rashalat offshore production units, where the crude oil is

prepared for final export. Both sustained damage from air attack, particularly the treatment units, and to date have only been partially reconstructed.

265. The island also contains a 20,000 b.p.d. topping plant, which produces some basic petroleum product needs and was seriously damaged in an air attack. The control centre, a sweetening plant and several large tanks were demolished. The mission was shown around the entire plant and was informed that restoration has been effected in the major areas and the plant is now about 75 per cent complete.
